DESIGN OF FLEXIBLE AIRFIELD PAVEMENTS FOR  
MULTIPLE-WHEEL LANDING GEAR ASSEMBLIES

REPORT NO. 1

TEST SECTION WITH LEAN CLAY SUBGRADE

TECHNICAL MEMORANDUM NO. 3-349

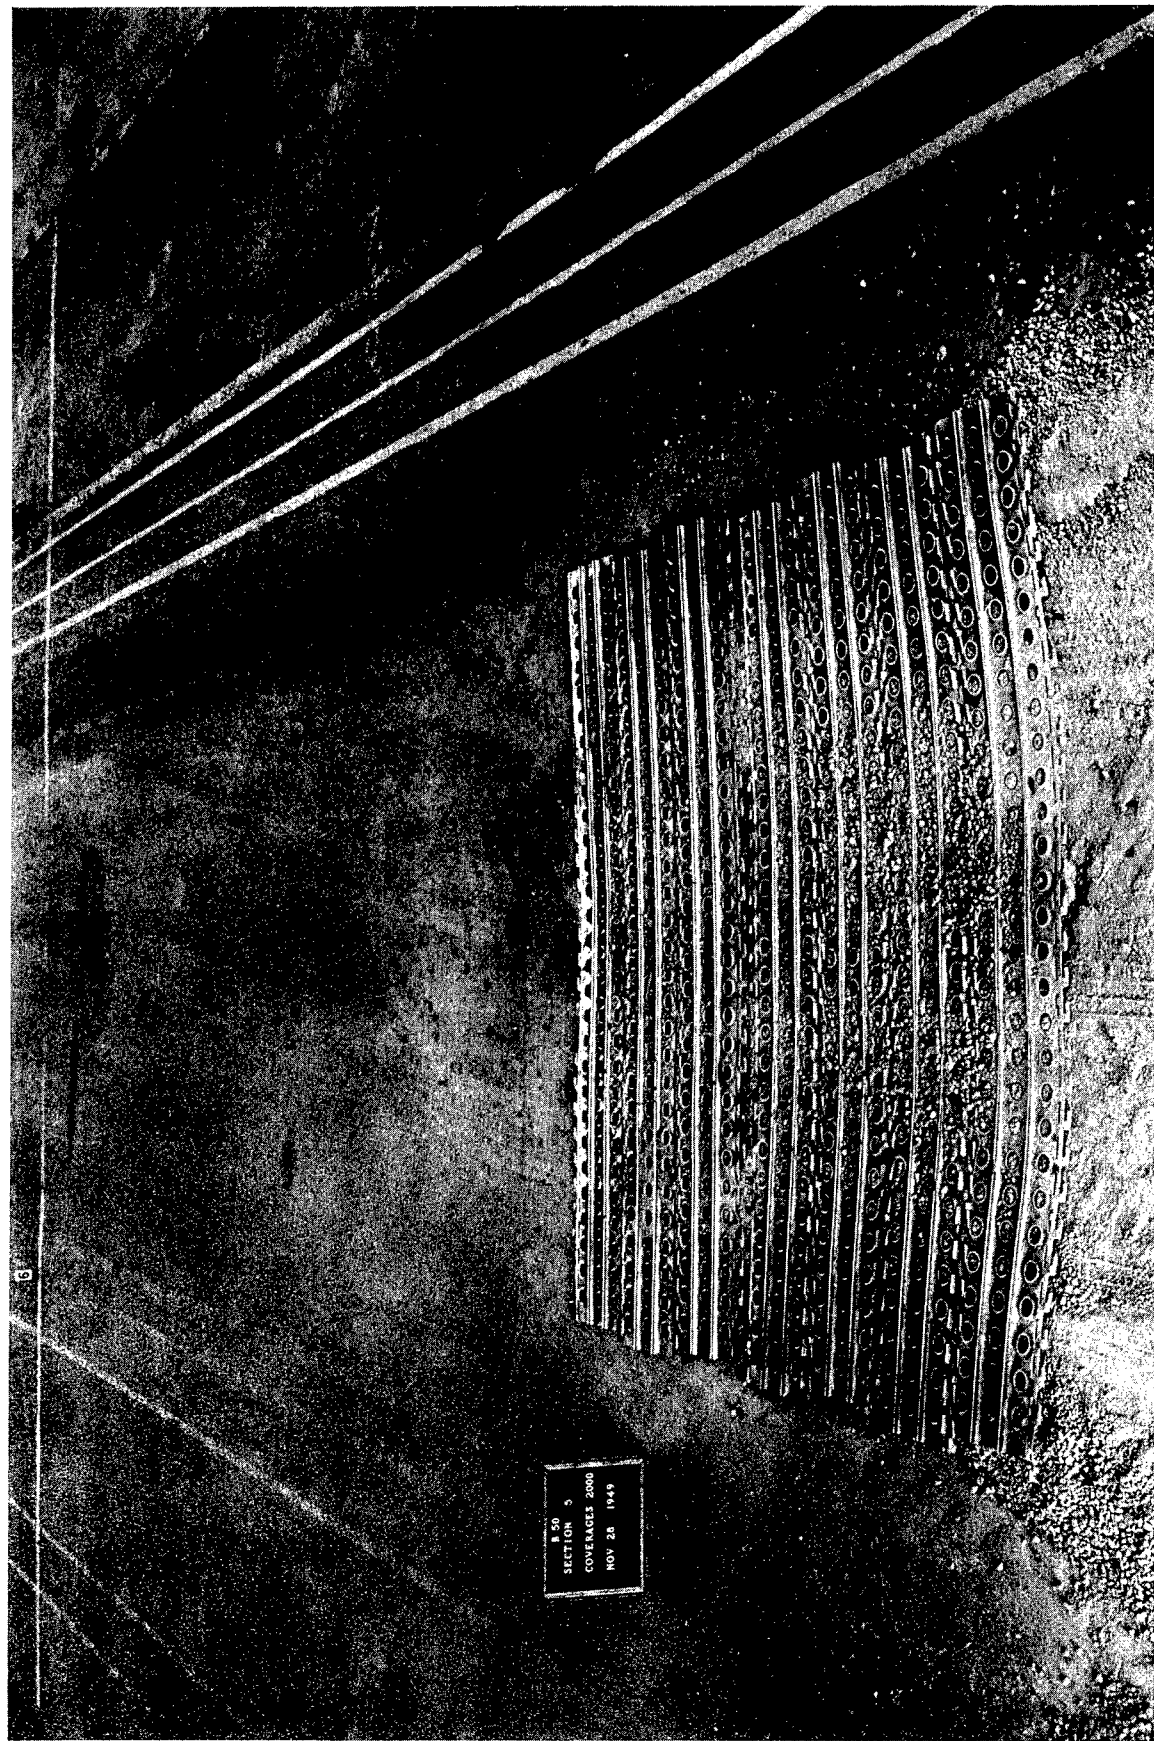
40. Unit 5, 15-in. thickness. The deflection of the subgrade under load increased from 0.205 in. at the first load application to 0.283 in. at 2,000 coverages. The maximum deformation of the surface was about 1.4 in. (see plate 14) and the maximum deformation of the subgrade at the gage point was about 0.6 in. (see plate 12). As shown in photograph 18, cracks progressed into this unit from unit 4. Unit 5 was considered failed at this end (stations 0+40 to 0+44) after about 700 coverages. The CBR of the subgrade in this area after 750 coverages (pit 12) was 18 per cent. Inasmuch as failure progressed into this portion of unit 5 from unit 4, it is considered that an analysis from the standpoint of thickness requirements would not be valid. Except for numerous small hair cracks, no distress was observed in the remainder of this unit during the application of 2,000 coverages. The CBR of the subgrade after 750 coverages (pit 13) was 26 per cent and after 2,000 coverages (pit 14) was 23 per cent. The average, 24 per cent, is considered pertinent for this portion of the unit. Photograph 19 shows the condition of this unit after 2,000 coverages. Except for south 4 ft the unit was evaluated as borderline.

Photograph 19. Unit 5, 15-in. thickness. View showing condition of pavement after 2,000 coverages with 100,000-lb load on B-50 assembly

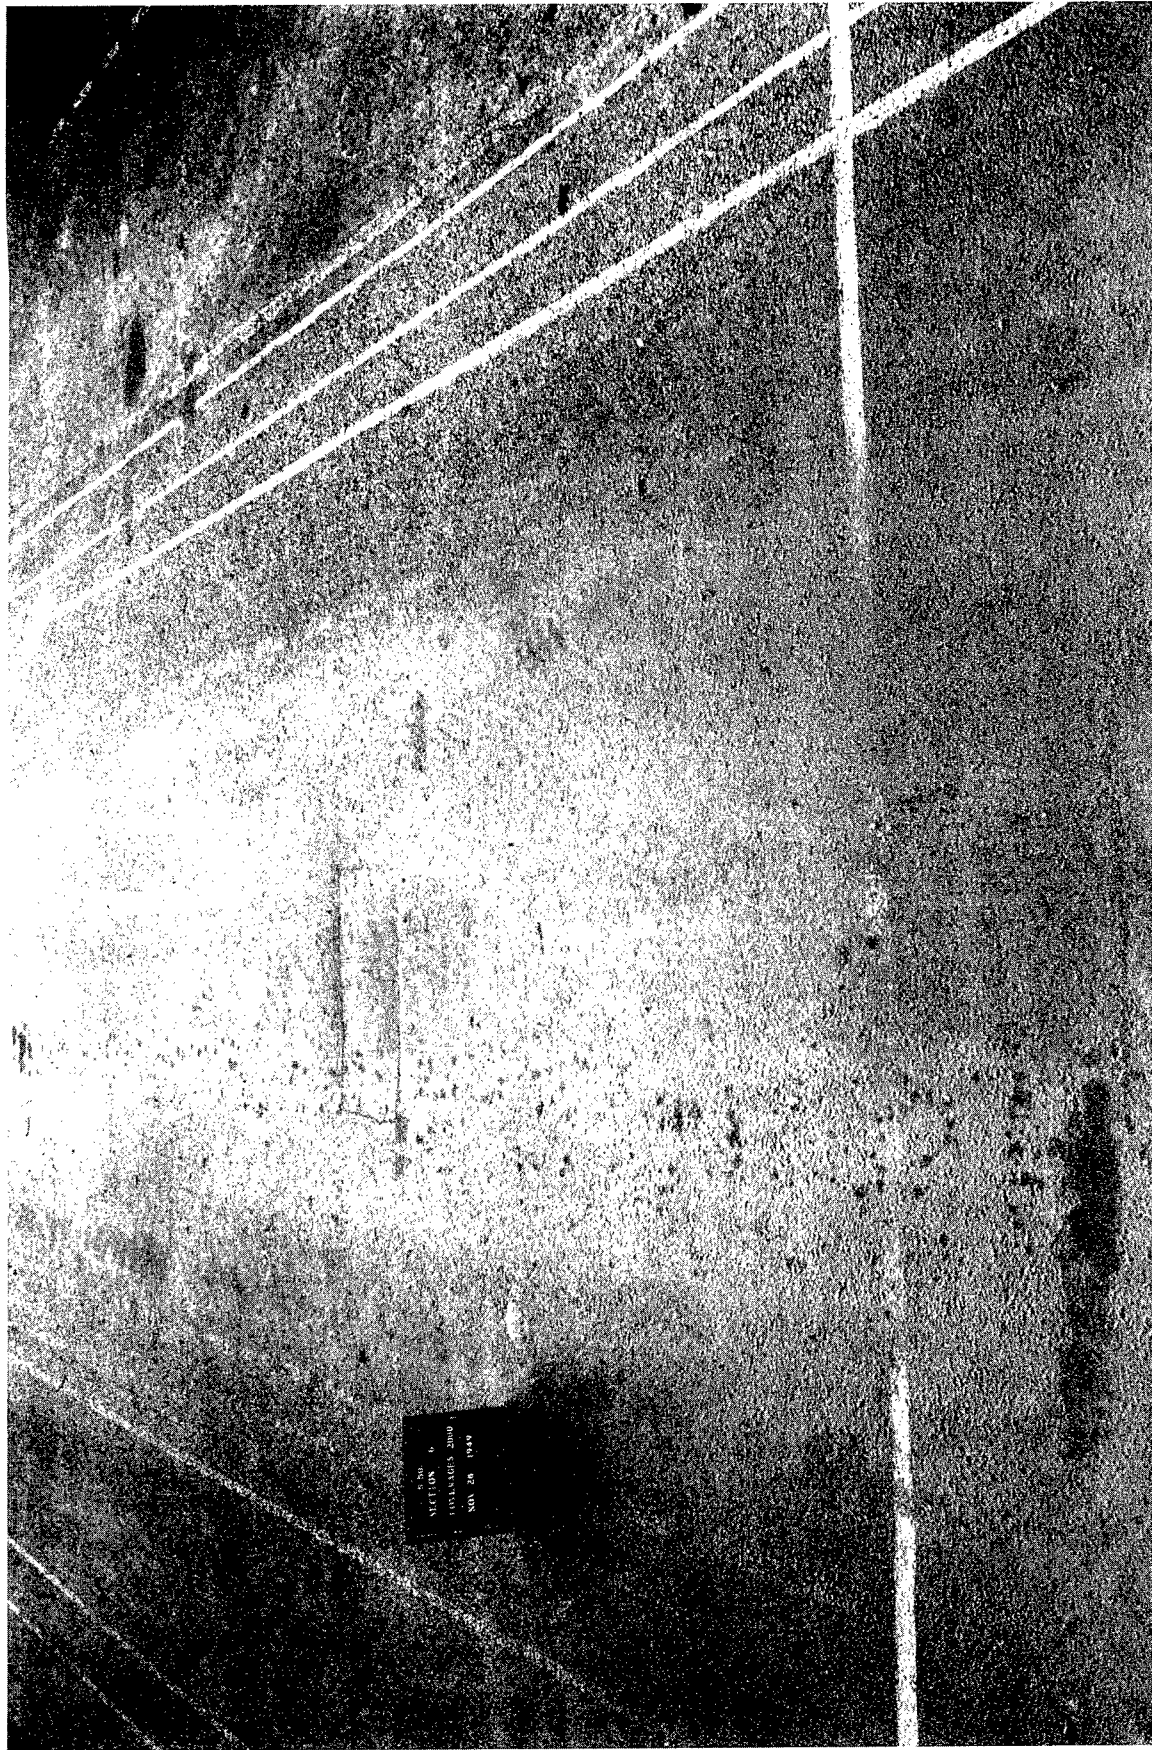
41. Unit 6, 20-in. thickness. The deflection of the subgrade under load increased from 0.188 in. at the first load application to 0.254 in. at 2,000 coverages. The maximum deformation of the surface was about 1.4 in. (see plate 14) and the maximum deformation of the subgrade at the gage point was about 0.4 in. (see plate 12). Photograph 20 shows the condition of this unit after 2,000 coverages. Except for slight hair cracks in the area around pit 18, no distress was observed in this unit during

Photograph 20. Unit 6, 20-in. thickness. View showing condition of pavement after 2,000 coverages with 100,000-lb load on B-50 assembly
